Rainwater treatment - Rehabilitation of existing concrete structures

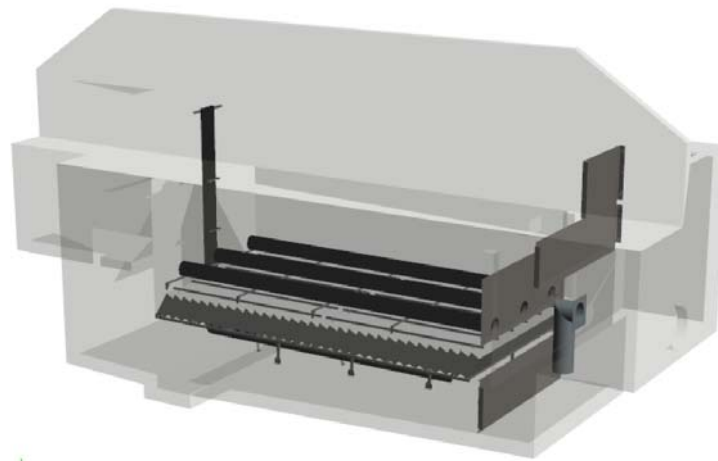
Figure 2 : 3D illustration of an existing concrete rehabilitation structure.

The figures below represent a concrete structure rehabilitated with the "counter-current lamellar settling" technology. The watershed size was 4.5 ha with a traffic area of around 20'000 vehicles/day. The expected treatment rate is 254 l/s.

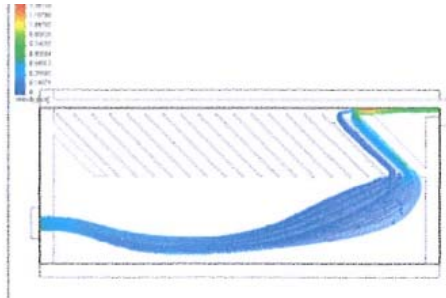
Figure 3 : Hydraulic flow before rehabilitation

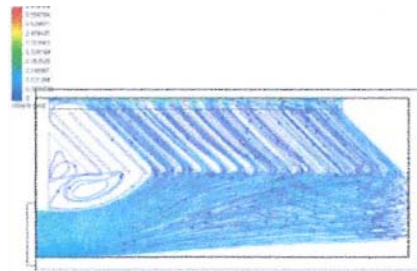
Figure 4 : Optimised flow after rehabilitation

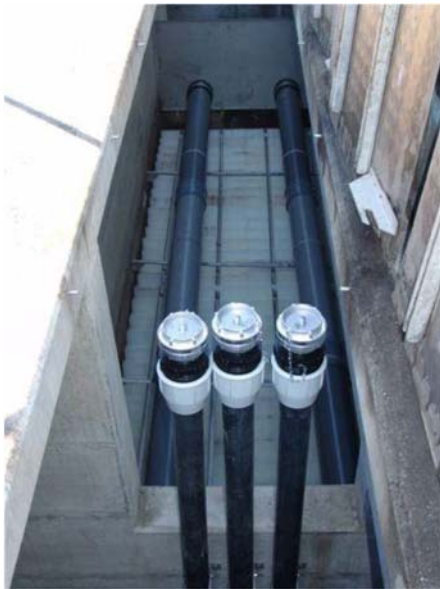
Figure 5 : Outlet siphon

A siphon located downstream of the structure allows the retention of light hydrocarbons.

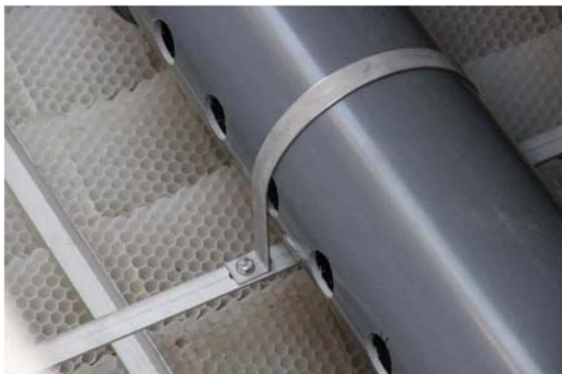
Figure 7 : View of the lamellar blocks lower part

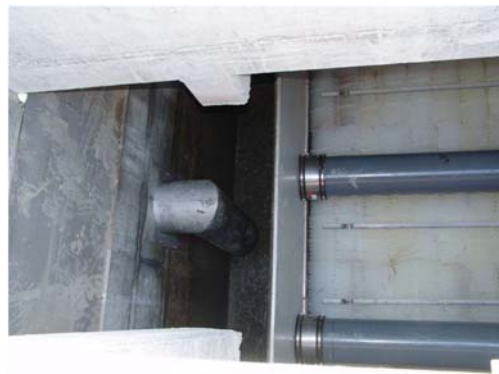
Figure 8 : Settled water channel
